Slide Tower

**Recommended Maintenance and Risk Assessment Evaluation**

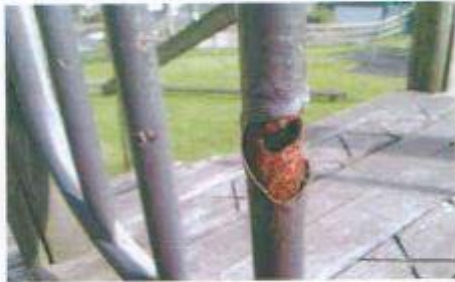
Comments, action or control required		Risk Level	Risk Score ±
<p>Item: Barriers</p> <p>Fixing Date: 08/09/2011</p> <p>Location: Barriers</p>

<p>There is significant corrosion on this item</p>	Medium	8
<p>Item: Deck planks</p> <p>Fixing Date: 08/09/2011</p> <p>Location: Deck planks</p>	<p>Descale back to good metal and coat with lead free paint, using appropriate precautions. Repairs may be necessary where corrosion is severe</p> <p>Timber - Rotting</p>	Low	6
<p>Item: Slide bar</p> <p>Fixing Date: 08/09/2011</p> <p>Location: Slide bar</p>	<p>Repair item</p> <p>Slide bar not fitted across the access to the slide</p>	Low	5
<p>Item: Monitor</p> <p>Fixing Date: 08/09/2011</p> <p>Location: Monitor</p>	<p>Monitor and check on a routine basis</p>
